# MiscRes: Factory Recalls

## Factory Recalls

This is a complete Factory Safety Defect Recalls (regarding Sportsters) from 1967-1979 of the MoCo's Motorcycle Safety Defect Recall Campaign. More will be added when found.

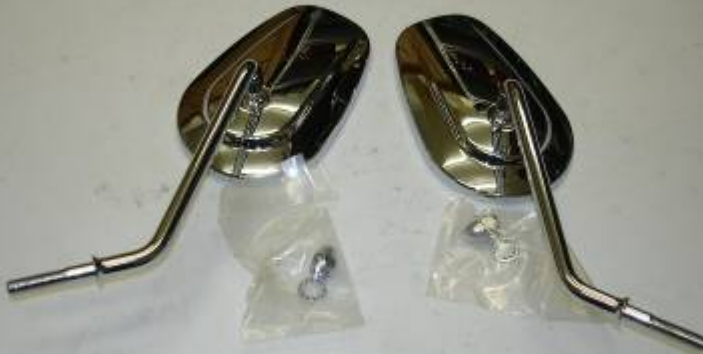
Mirror Kit (94190) for HD Safety Recall Code 0108  
regarding 2002 XL1200C motorcycles

Right side mirror (91846-03), Left side mirror (91848-03)

| Year Model | Recall # | Recall Date | TSB # | Subject | Sportster VIN Range |
|---|---|---|---|---|---|
| <p>For Any XL1200C assembled/shipped from the Kansas City, Missouri plant equipped long stemmed mirrors (left 91902-88A and right 91904-88A). Certain 2002 model year 1200 Custom Sportster motorcycles have a condition whereby the left side mirror stem may fracture. This may allow the mirror to fall, possibly without warning, and present an unreasonable risk of accident, injury or death. In the interest of motor vehicle safety and customer satisfaction, HD elected to initiate a voluntary recall to replace both mirrors on all affected motorcycles with current production parts. See TSB M-1136 for dealer action required to perform the recall service.</p> <p><a href="#">Click Here</a> to go to the TSB page in the Sportsterpedia.</p> <p>Scroll down to bulletin M-1136, click on the "Y" in the chart to download the service bulletin.</p> | | | | | |

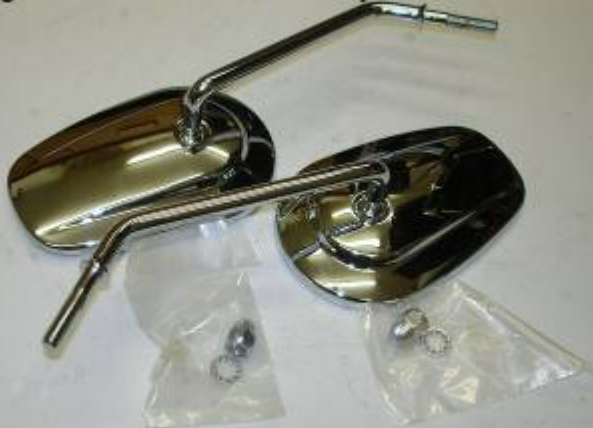
Mirror Kit (94190) for HD Safety Recall Code 0108  
regarding 2002 XL1200C motorcycles

Right side mirror (91846-03), Left side mirror (91848-03)
