## XLH/XLS SERVICE INFORMATION

### Transmission Vent Hose Routing — 1981 Models

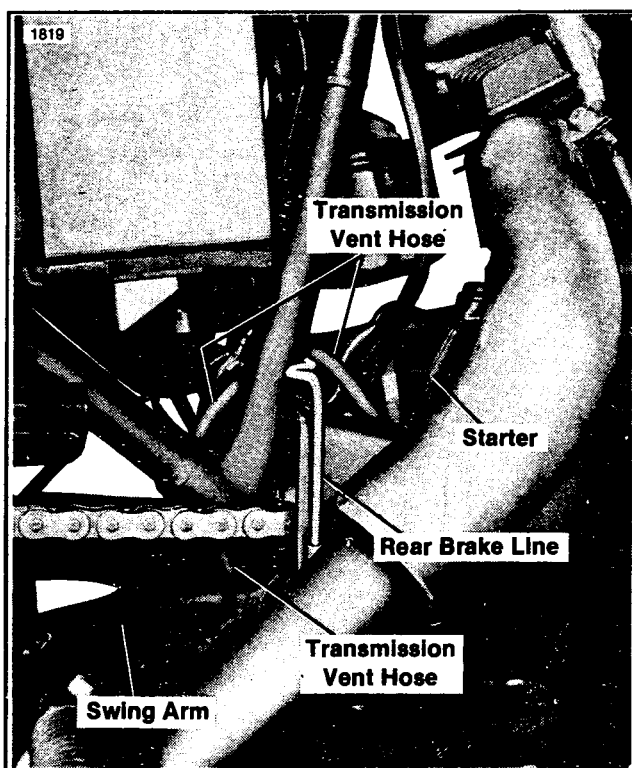
Figure 1. Routing Transmission Vent Hose

The transmission vent hose routing on the 1981 XLH/XLS models was recently changed to reduce excessive oil leakage from the transmission. Early 1981 models can be changed to the new routing.

See Figure 1. The transmission vent hose should be routed under the starter, over all the oil lines and the rear brake line, then down between the pivot bolt and swing arm.
