# SERVICE BULLETIN

M-910

September 17, 1985

# EVOLUTION 1100cc SPORTSTERS VACUUM OPERATED ELECTRIC SWITCH

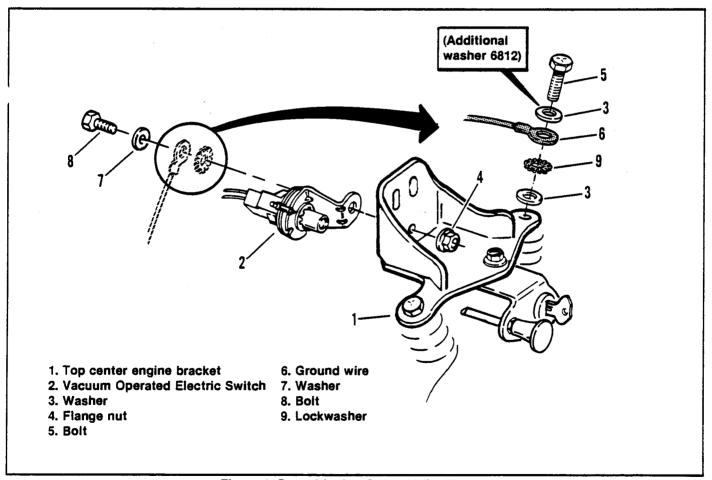
Figure 1. Repositioning Ground Wire Mount

On 1986 1100cc Sportsters, a mid-year production change has rerouted the Vacuum Operated Electric Switch, ground wire, to a different mounting location. The new location for anchoring the ground wire improves electrical conduction to ground. All 1100cc vehicles produced after VIN 1HD1CAN10GY115548 have this change. Motorcycles with an earlier VIN may also require this change. Improper grounding of the Vacuum Operated Electric Switch will cause erratic idle, poor low speed operation

or difficulty in locating the ignition timing mark.

- 1. Remove V.O.E.S. mounting bolt (8), washer (7) and nut (4).
- 2. Disconnect V.O.E.S. ground wire (6) and washer (9) from bolt (8). Attach V.O.E.S. switch to bracket (1) with bolt (8) washer (7) and nut (4). Tighten nut (4) to a torque of 20 ft lbs.

Check to be sure V.O.E.S. does not contact engine rocker box. Normal engine vibration and heat could damage switch.

- 3. Remove the rear cylinder bracket bolt (5) and washer (3).
- 4. Place an additional washer HD Part No. 6812 on bolt (5), followed by ground wire (6), washer (9) and original washer (3). Thread bolt (5) into cylinder and

Check to be sure ground wire is not contacting engine rocker box. Normal engine vibration and heat could damage switch wire.
