# SERVICE BULLETIN

B-071

Product Program 0502

## 2008 1125R CALIBRATION AND STARTER SOLENOID PRODUCT PROGRAM 0502

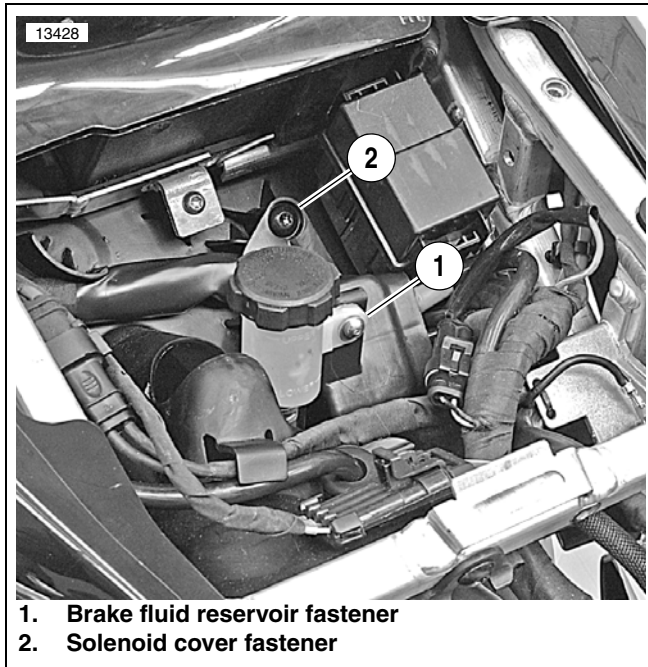
Figure 1. Starter Solenoid Cable Fasteners

This bulletin also communicates an updated starter solenoid fastener torque procedure to improve battery cable retention and circuit integrity.

- Remove the seat.
- Disconnect negative battery cable.
- See Figure 1. Remove the brake fluid reservoir fastener (1).
- Remove solenoid cover fastener (2) and the cover.
- See Figure 2. Remove starter solenoid cable fasteners (4) and washers.
- Apply blue Loctite 243 (blue) to the fasteners (4).
- Install starter solenoid cable nuts and tighten to 43-48 in-lbs (4.8-5.4 Nm).

8. See Figure 1. Install solenoid cover and fastener (2). Tighten fastener to 37-60 **in-lbs** (4.1 to 6.8 Nm).
9. Install brake fluid reservoir and fastener (1) and tighten to 32-36 **in-lbs** (3.6-4.1 Nm)
10. Connect negative battery cable.
