# REF: Service Procedures 9U

## Transmission Access Door Alignment

Transmission door “alignment” explained. (Dr Dick) <sup>1)</sup>

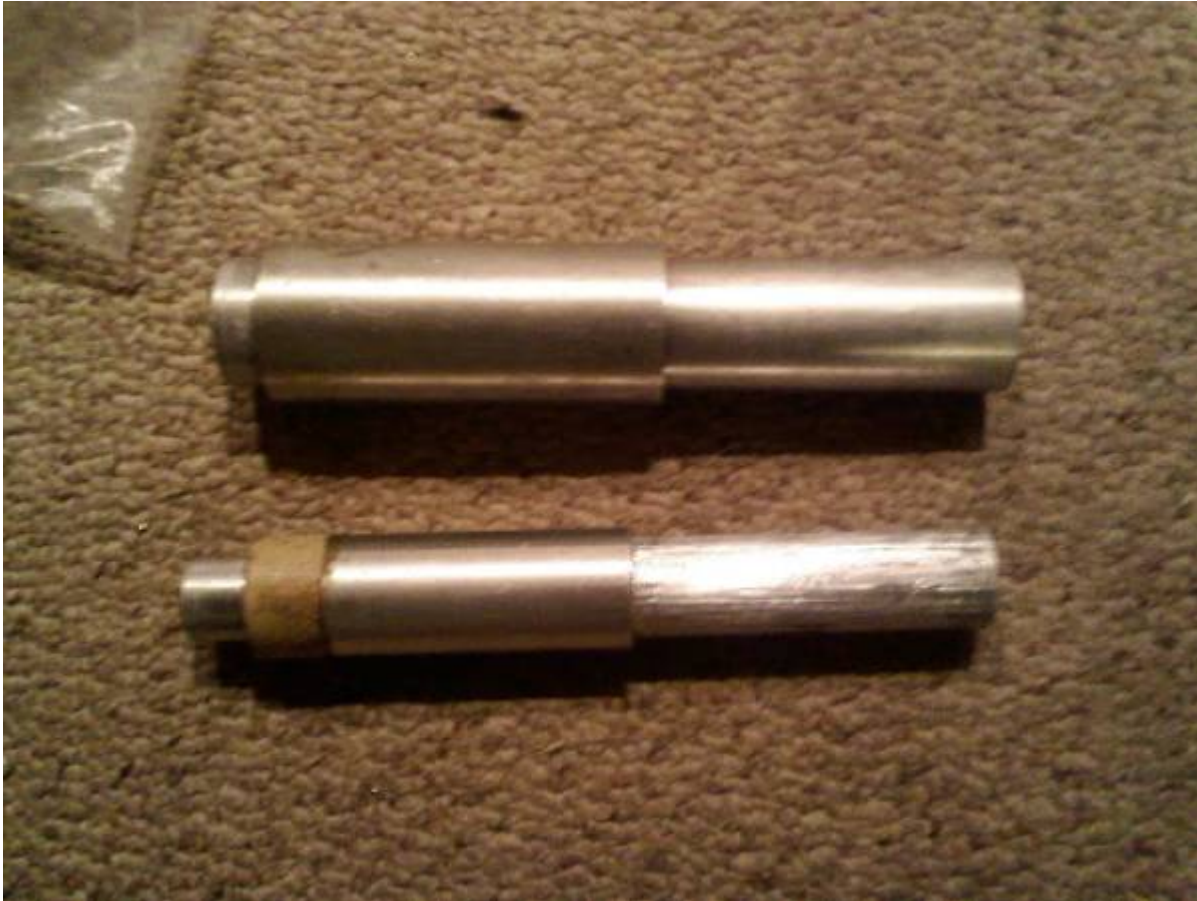
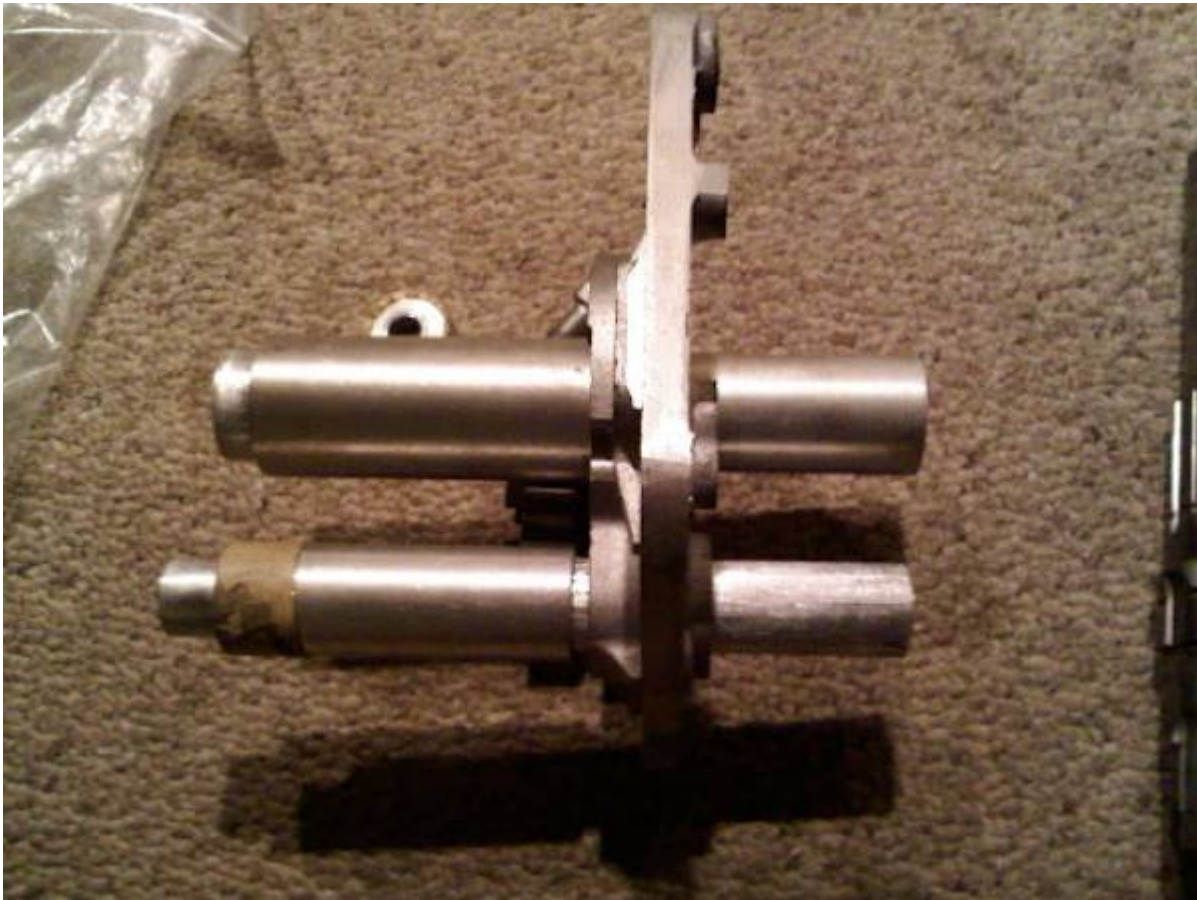
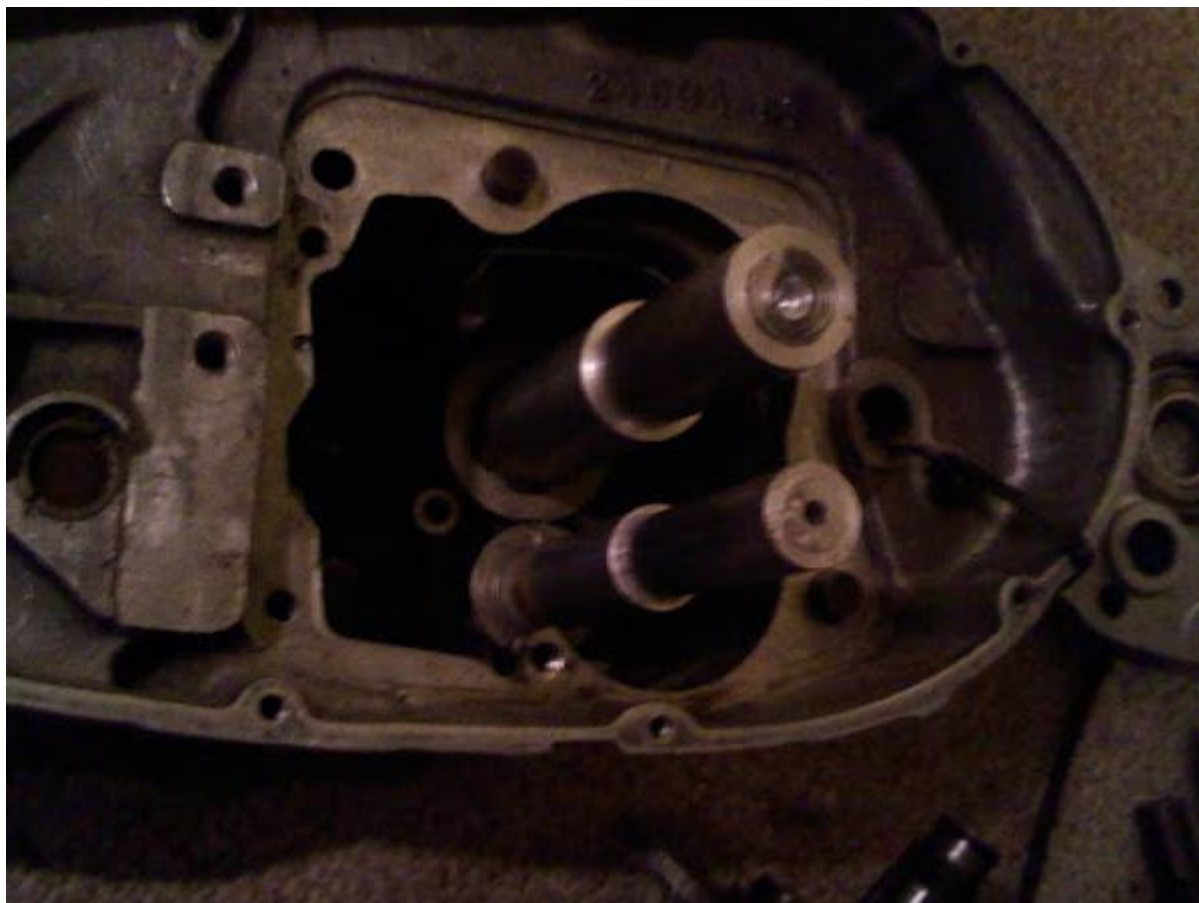
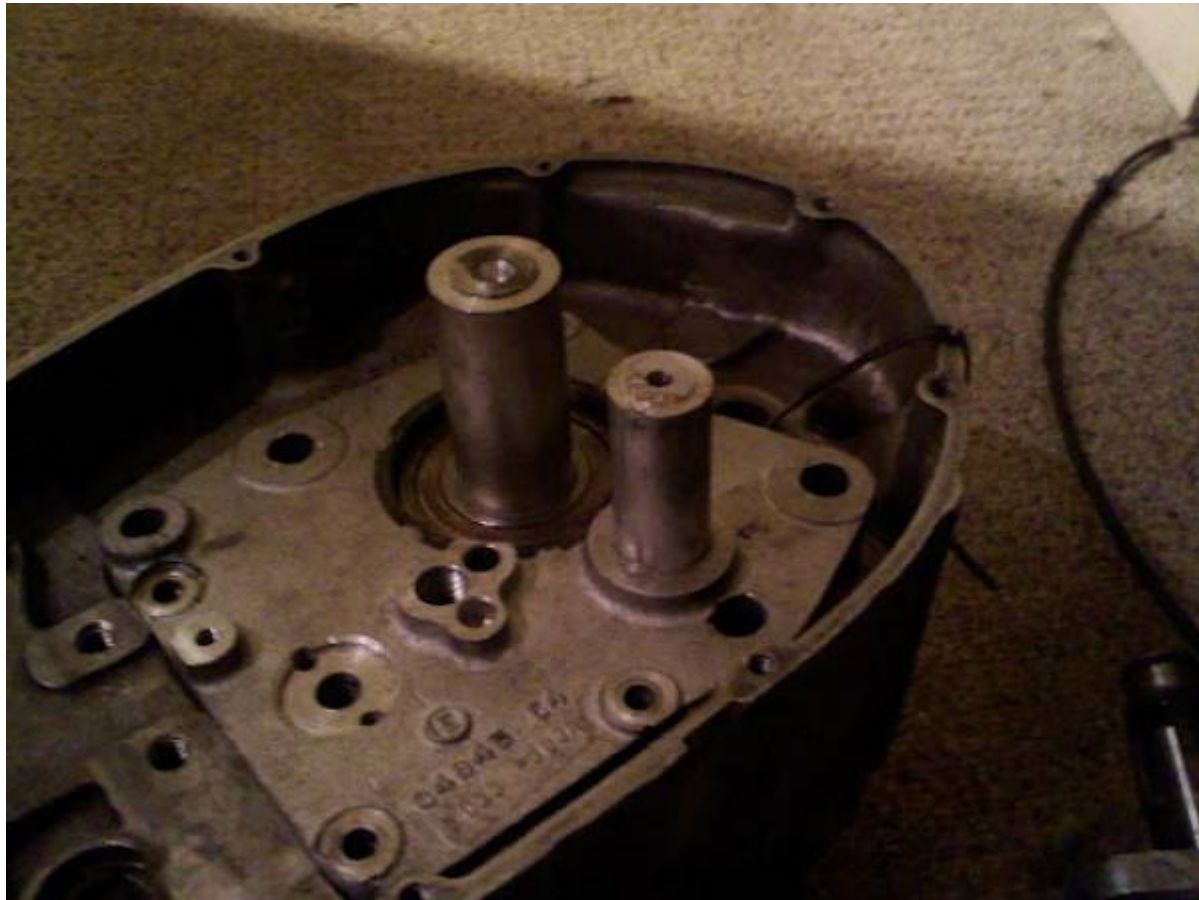
But the relative position of the 4 bolt holes to the dowels is not constant due to all the positioning variances that come into play when the door is first attached to case half. So the misalignment of the

bolts is not indicative of misalignment of the trans bearing bores.

Check out the bolt holes in this 72 door. This is very common on swapped doors.

So, pull the transmission. Pull the dowels. In a mill, reshoot door dowel holes in correct position. Dia of holes to large enuff that the same size hole will give a good bore for case side of new pins to be solid. In position and press fit.

Buy a chucking reamer of correct size that will cut holes in case. This reamer is .001" smaller than new door holes. So when reaming case the door hole will act as a reamer guide.

For hole position in case to be in correct spot, the reamer needs to be guided at 2 places along it's length. These locations in relation to the case aren't arbitrary. They need to be on location so holes the reamer makes is also on location.

This is how I made that happen. As chevelle said, I made concentric mandrels. One end of each fits in main and counter bear bores of right case. The other end of mandrels fits thru door bear bores.

This is how it's done with precision.
