# Parts & Accessories Bulletin

PAB #387

## XL 883 HORN KIT P/N 69014-88 INSTRUCTION SHEET CORRECTION

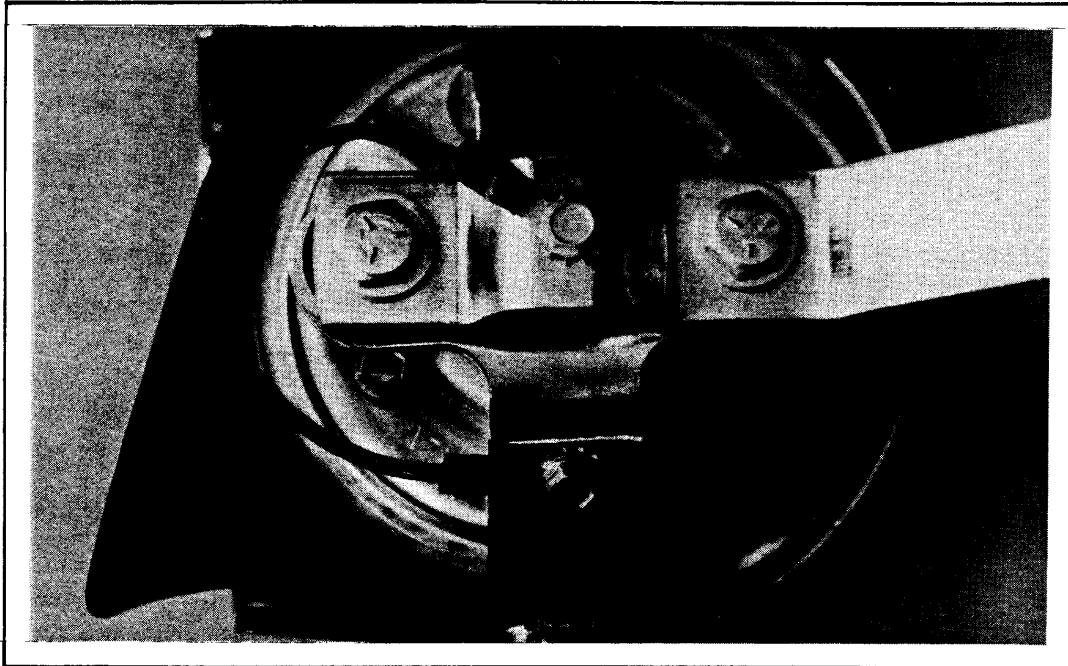
The instruction sheet supplied with this kit is incorrect.

The correct routing of the ground wire (step #4) is from the horn mounting bracket to the back side of the chrome horn cover. Please refer to the photo for correct installation.

Horn kits packaged after 7/15/88 will have corrected instruction sheets.
